# **Asbestos Characterization Report**

## **Addendum to Building 123 Inspection**

**Rocky Flats Environmental Technology Site**

**Revision 1  
June 6, 1997**

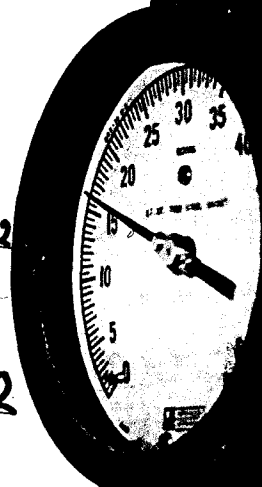
123-970408-MS-012

The vapor barrier mastic on the pipe insulation in mechanical room 132 was sampled and analyzed for asbestos. The sample results indicate that there is no detectable asbestos in this material.
